# Kidwelly Flood Investigation Report

A report into the flooding events of the 4<sup>th</sup> and 20<sup>th</sup> October 2021 at Clos Y Helyg, Parc Pendre, Llys Gwenllian, Ferry Road, Cae Ffynnon, Ger Y Castell, Ger Y Gwendraeth and Kidwelly Industrial Estate – as required under section 19 of the Flood and Water Management Act 2010.

<b>Title of document</b>	Kidwelly Flood Investigation Report
<b>Document date</b>	September 2022
<b>Authors</b>	Carmarthenshire County Council
<b>Service responsible</b>	Flood Defence and Coastal Protection, Waste and Environmental Services
<b>Department</b>	Environment
<b>Review</b>	Cath Abbott Flood Defence and Coastal Protection Engineer Environment Department, Carmarthenshire County Council
<b>Approval</b>	Ben Kathrens Flood Defence and Coastal Protection Manager Environment Department, Carmarthenshire County Council
<b>Published</b>

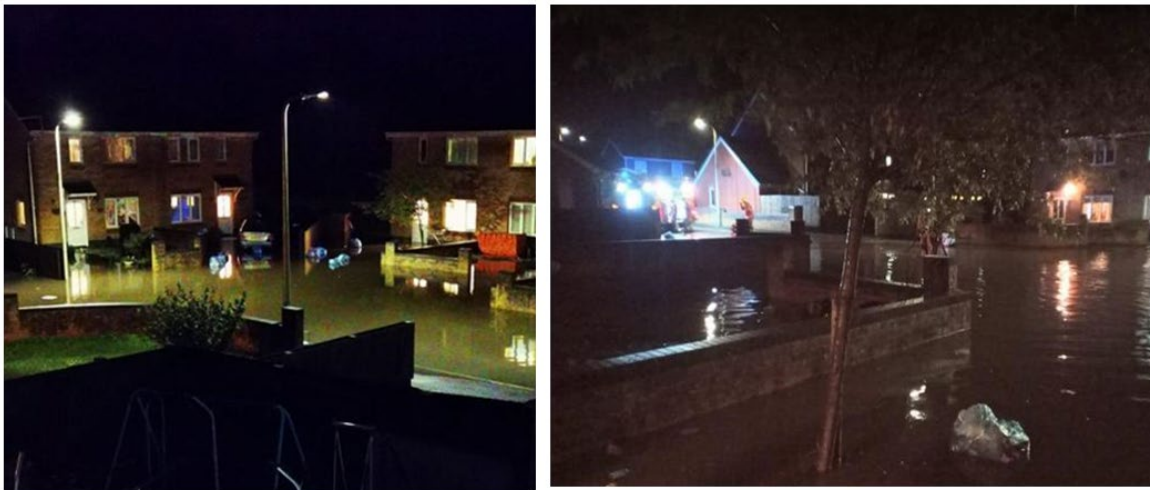
Figure 6 - Photos of the flooding at Clos Yr Helyg on the 4<sup>th</sup> October 2021 (Gemma Wilby).

- 7.7.1 On both the 4<sup>th</sup> and 20<sup>th</sup> October 2021, residents in Clos Yr Helyg experienced significant flooding. On the evening of the 4<sup>th</sup> October 2021, 20.3mm of rain fell in just 2 hours and 9 homes were flooded internally. On the morning of the 20<sup>th</sup> October 2021, 32.9mm of rain fell in just one hour (41mm in a 2-hour period) and the same 8 properties were flooded. Both events could be described as ‘flash flooding’ events where a day’s worth of rain falls over a significantly shorter period.

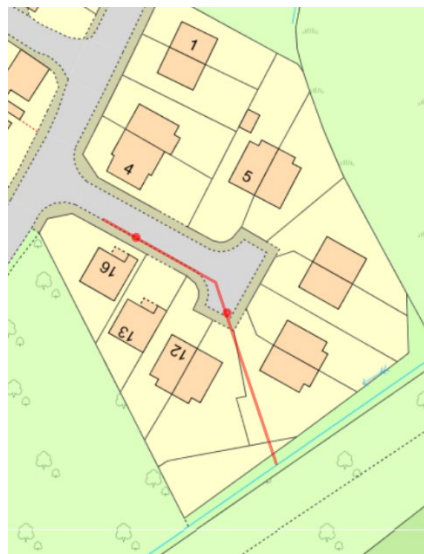
Figure 13 - Map of the highway drainage system at Clos Yr Helyg, Kidwelly.

7.5.2.6 The 2019 CCTV survey did attempt to survey the Clos Yr Helyg highway drainage system. However, this investigation has discovered that the survey was not completed because of silts and water in the line. Water in the line would suggest defects in the system. This investigation has been unable to find any records that these defects were reported, recorded, or resolved.

Undertake a CCTV survey of the highway drainage system down Clos Yr Helyg in order to have a better record of CCC assets and action any defects accordingly.

Develop a more robust method of reviewing CCTV drainage surveys and recording and actioning defects between divisions and teams.

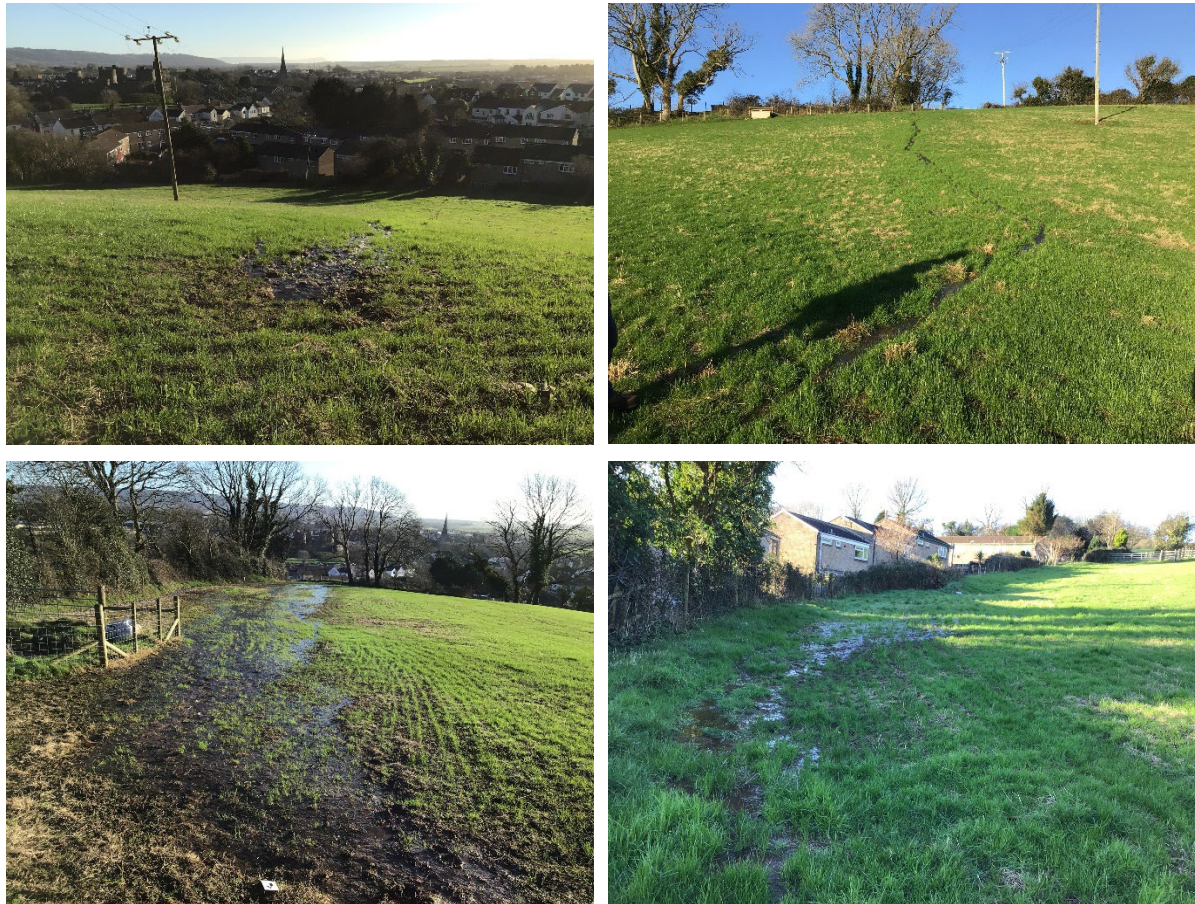
- 8.4.3 On the 12<sup>th</sup> January 2022, officers from Pobl and CCC's FDCP team visited Llys Gwenllian to discuss the drainage issues. After an inspection of the area, CCC officers inspected the fields to the north of Llys Gwenllian. There they observed multiple springs discharging water which subsequently flow down to the rear of Llys Gwenllian (Figure 18).

Figure 18 – Photographs of the springs discharging water towards Llys Gwenllian.

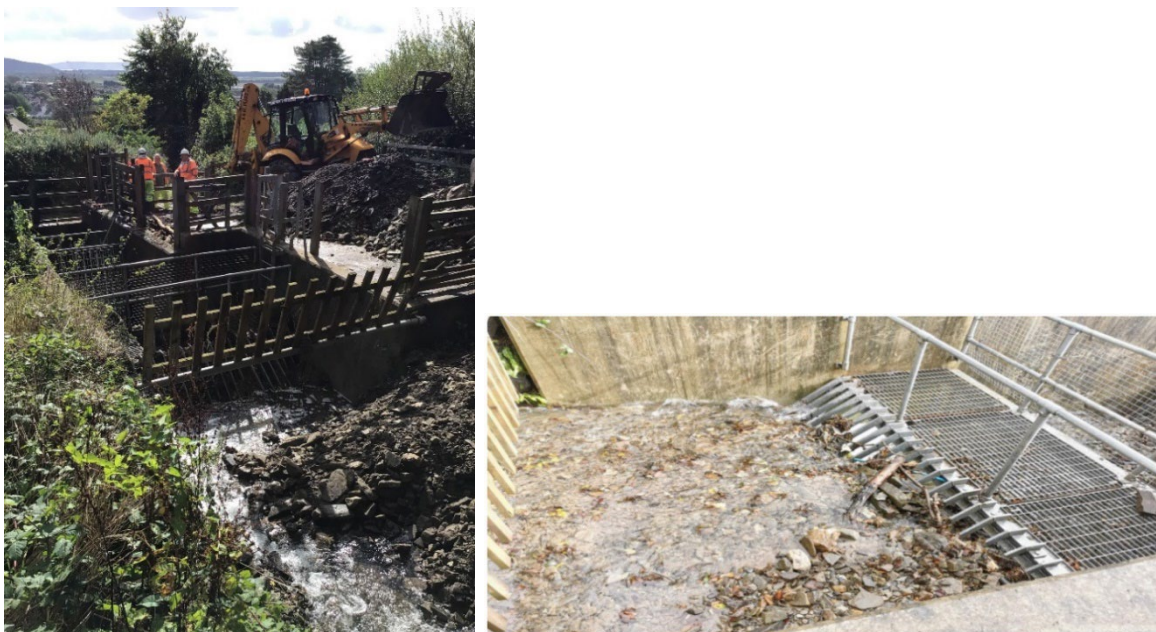
Figure 22 - Photos of the debris removed after the flooding event on the 4<sup>th</sup> October 2021 at Cae Ffynnon.

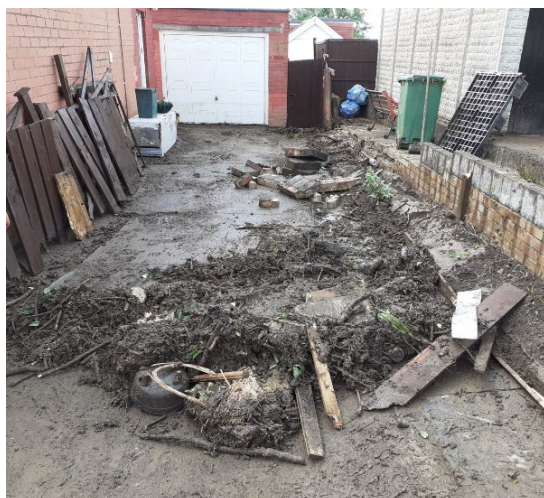
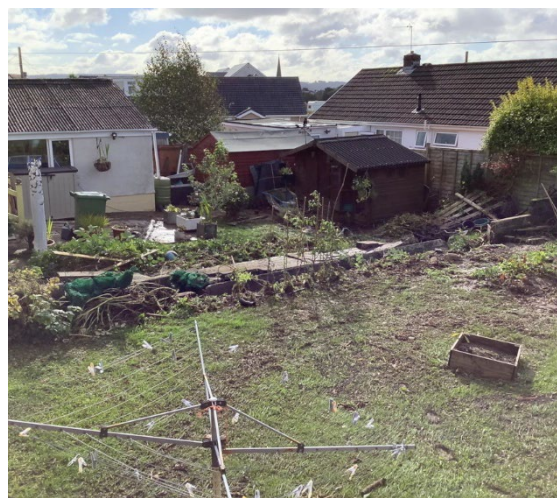
Figure 23 - Photo of the debris removed after the flooding event on the 4<sup>th</sup> October 2021 at Ferry Road.

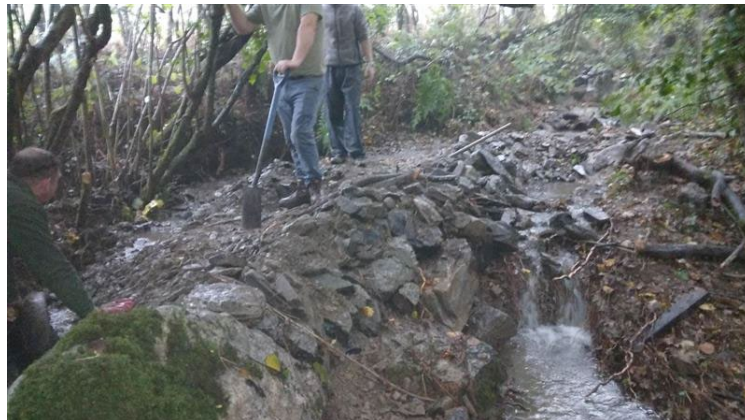
Figure 24 – Photo of Kidwelly residents unblocking the Cae Ffynnon watercourse north of Cae Ffynnon. In the picture, the water is flowing down the footpath, the watercourse is where the men are standing.

- 10.7.3 Initially, there were many hypotheses pertaining to the source and cause of the flooding. It is now clear that the flooding that occurred on both the 4<sup>th</sup> and 20<sup>th</sup> October 2021 was caused by the ordinary watercourse above Cae Ffynnon breaking its banks. Water escaping the watercourse was unable to re-join the channel and was funneled down the footpath to the rear of Cae Ffynnon and then on to Ferry Road.

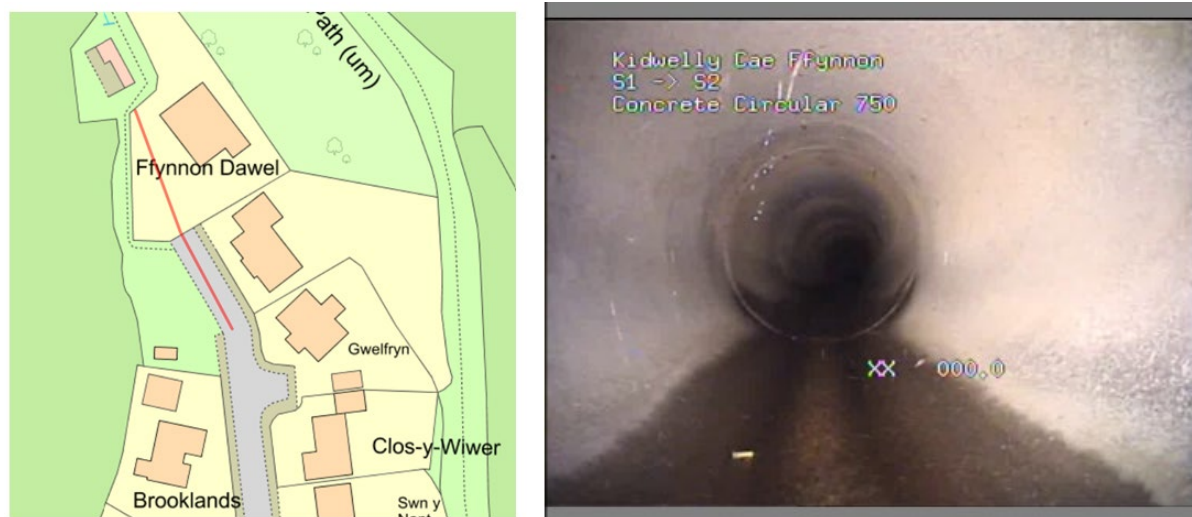
Figure 28 - The private section of culverted watercourse at Cae Ffynnon Kidwelly.

10.6.1.3 Downstream of the [Cae Ffynnon Trash Screen](#), (see section 5.6.2.1) there is an approximately 265 meter long section of privately owned, culverted watercourse, as denoted in Figure 28. This section of culvert is a concrete pipe, 750mm in diameter, which was last surveyed on the 24<sup>th</sup> September 2018. No defects or concerns were noted during that survey and the culvert is regarded as being in good condition.

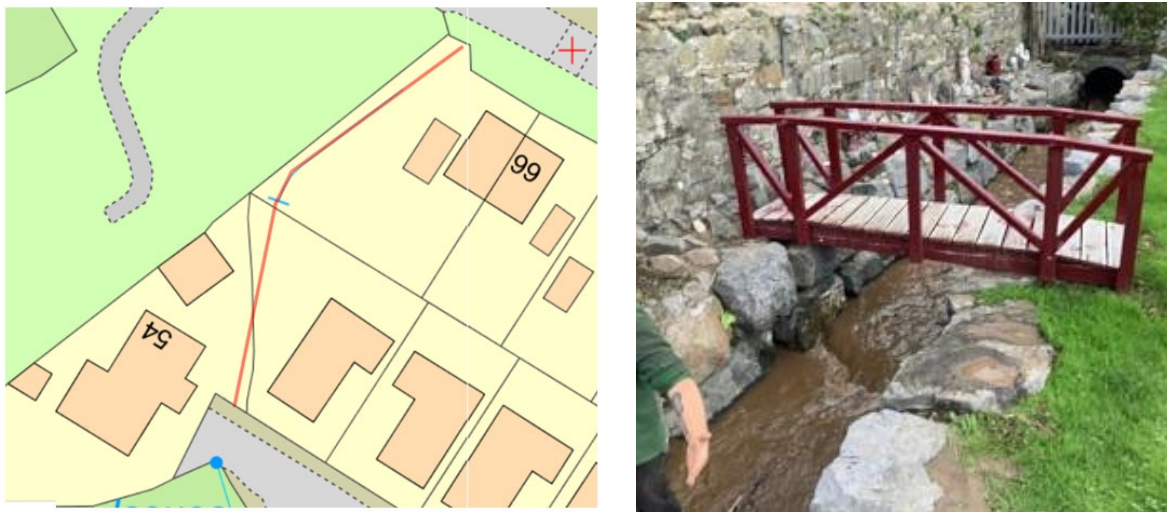
10.6.1.4 In addition to the above, the lower reaches of the ordinary watercourse are also in private ownership, as denoted in Figure 29 below. There are two sections where the watercourse is culverted in a 900mm diameter culvert. The condition of this culvert is unknown at the time of writing but the catchment analysis suggests that a

Figure 29 - Photos of the private sections of watercourse at 68 Ferry Road, Kidwelly.

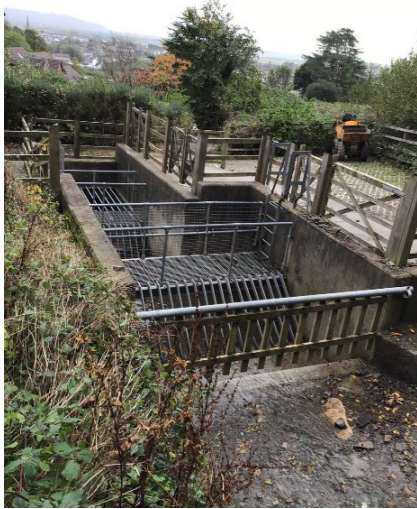
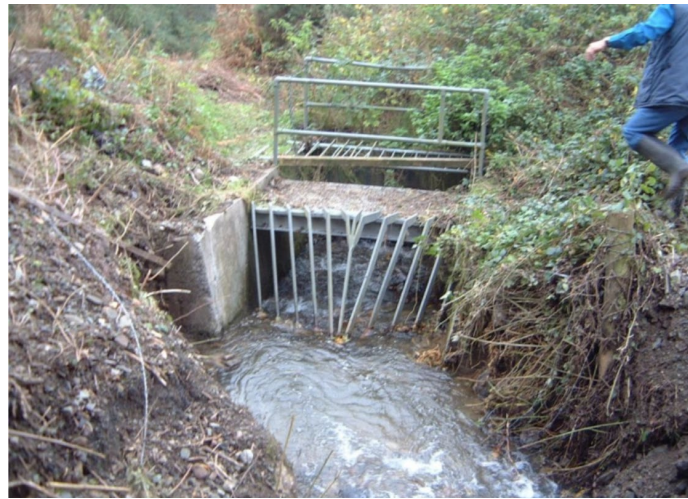
Figure 30 – On the left, the new trash screen as seen today, on the right, the screen that was replaced in 2014.

10.6.2.1.2 The Cae Ffynnon trash screen was upgraded in 2014/2015, as a part of a £70,000 CCC FDCP capital works scheme in the area.

10.6.2.1.3 An evaluation undertaken as a part of this investigation has concluded that this asset is fit for purpose, with the ability to manage flood flows up to the 1 in 100-year annual probability flood event (1% AEP). **Error! Reference source not found.** below depicts the flood modelling outputs and shows no predicted flooding during the modelling of this storm event.

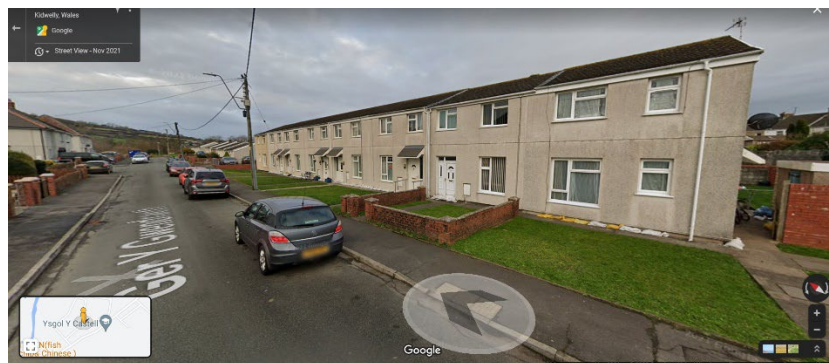
Figure 37 – Photo of the properties at Ger Y Gwendraeth that were flooded.

- 11.4.4 The Property Maintenance Supervisor noted that houses No.1-7 on Ger Y Gwendraeth lie beneath the level of the road. As such water flooding from the highway flows down to the dwellings and causes flooding.

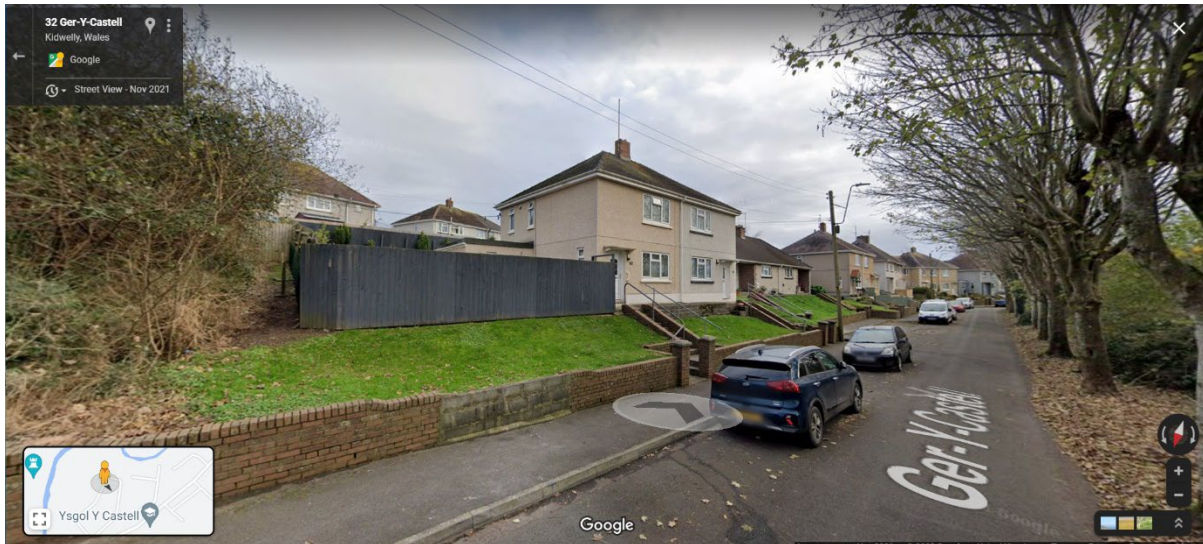
Figure 38 – Photo of 32 Ger Y Castell that had internal flooding from the rear.

11.4.6 It was noted that No.32 Ger Y Castell lies towards the bottom corner of the estate and is lower than surrounding properties. Detailed plans of the drainage servicing this area are not currently available.

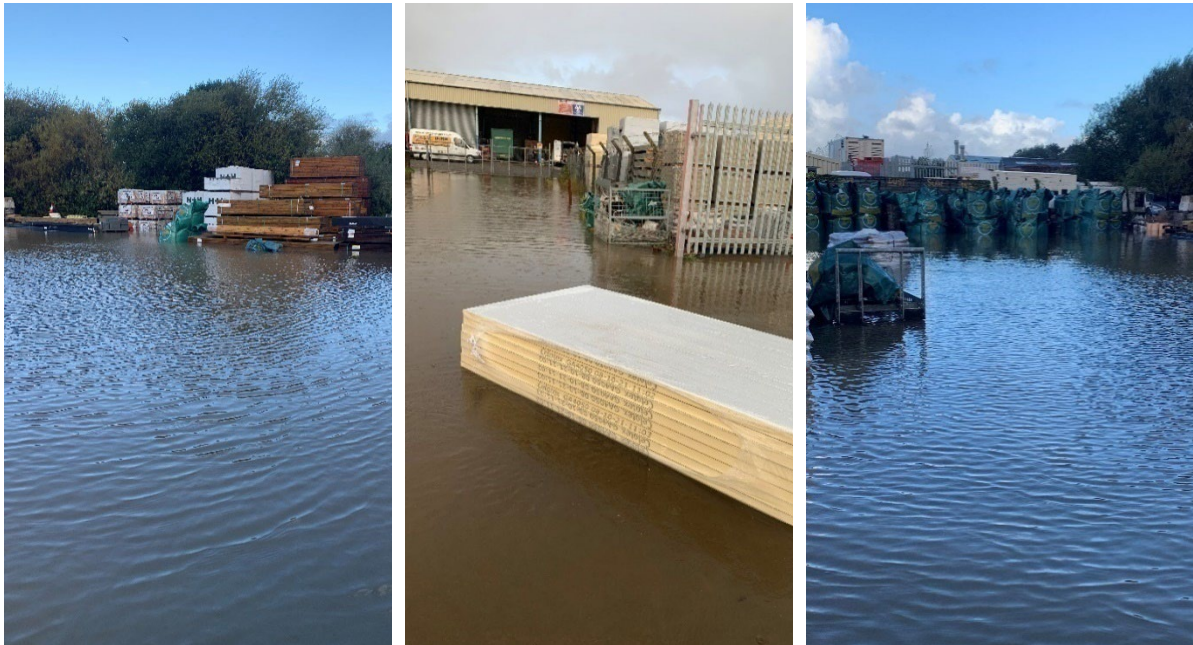
Figure 42 – Photos of the flooding at Kidwelly Industrial Estate on the 20th October 2021.
