# Kidwelly Flood Investigation Report

A report into the flooding events of the 4<sup>th</sup> and 20<sup>th</sup> October 2021 at Clos Y Helyg, Parc Pendre, Llys Gwenllian, Ferry Road, Cae Ffynnon, Ger Y Castell, Ger Y Gwendraeth and Kidwelly Industrial Estate – as required under section 19 of the Flood and Water Management Act 2010.

<b>Title of document</b>	Kidwelly Flood Investigation Report
<b>Document date</b>	September 2022
<b>Authors</b>	Carmarthenshire County Council
<b>Service responsible</b>	Flood Defence and Coastal Protection, Waste and Environmental Services
<b>Department</b>	Environment
<b>Review</b>	Cath Abbott Flood Defence and Coastal Protection Engineer Environment Department, Carmarthenshire County Council
<b>Approval</b>	Ben Kathrens Flood Defence and Coastal Protection Manager Environment Department, Carmarthenshire County Council
<b>Published</b>

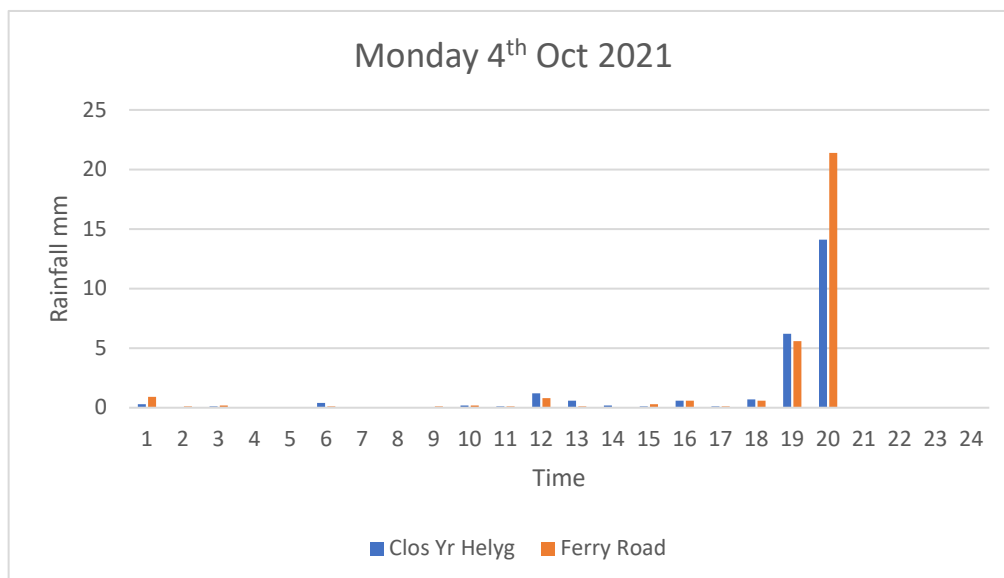
Figure 1 - Published MetDesk rainfall amounts in Kidwelly for each hour on the 4<sup>th</sup> October 2021 (mm).

6.4.1 Carmarthenshire County Council’s weather service provider, MetDesk, can provide rainfall amounts in millimeters (mm) for any hour throughout the day. The recorded radar rainfall amounts per hour (mm) for Clos Yr Helyg and Ferry Road are shown below in Figure 1. Between 18:00pm and 20:00pm, 20.3mm and 27mm of rain fell at Clos Yr Helyg and Ferry Road, respectively. To place the rainfall intensity in context, 30mm of rainfall in a 24-hour period is a standard trigger for action by Carmarthenshire County Council.

6.4.2 The MetDesk 24-hour rainfall totals for Monday 4<sup>th</sup> October 2021 were 25.1mm at Clos Yr Helyg and 31.4mm at Ferry Road. As can be seen from Figure 1 above, the vast majority of

the 24-hour rainfall total (more than 80%) fell over 2 hours from 18:00pm to 20:00pm. The cumulative radar 24-hour rainfall totals are shown below in Figure 2.

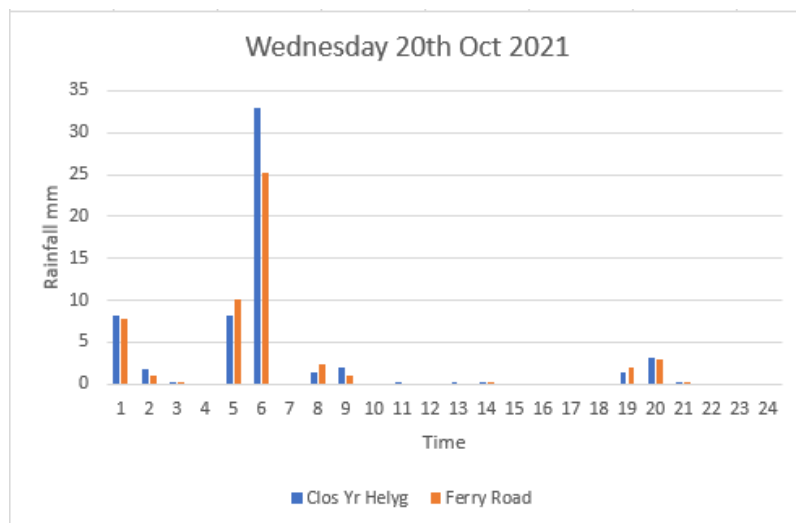
Figure 3 - Recorded rainfall amounts in Kidwelly for each hour on the 20<sup>th</sup> October 2021 (mm).

6.5.1 The recorded radar rainfall amounts for Clos Yr Helyg and Ferry Road are shown below in Figure 3 - Recorded rainfall amounts in Kidwelly for each hour on the 20<sup>th</sup> October 2021 (mm).. During the hour from 04:00am to 05:00am there was 8.1mm rain recorded at Clos Yr Helyg and 10.1mm at Ferry Road. Between 05:00am and 06:00am, 32.9mm and 25.2mm of rain fell at Clos Yr Helyg and Ferry Road, respectively.

6.5.2 The MetDesk 24-hour rainfall totals for Wednesday 20<sup>th</sup> October 2021 were 60.1mm at Clos Yr Helyg and 53.1mm at Ferry Road. As can be seen from

6.5.3 Figure 3 above, approximately 50% of the 24-hour rainfall total fell during one hour from 05:00am to 06:00am. The cumulative radar 24-hour rainfall totals are shown below in Figure 4.

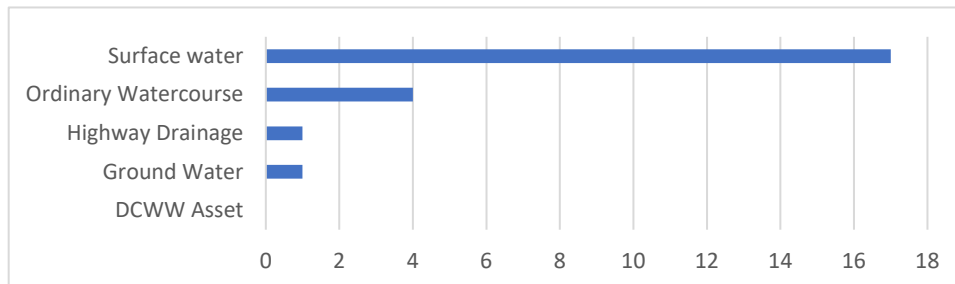
Figure 7 – The source of property flooding on the 4<sup>th</sup> October 2021, as recorded by CCC residents.

7.2.11 Of all the reports of internal property flooding received by CCC, the vast majority of residents reported the source as 'surface water' as shown in Figure 7 below.

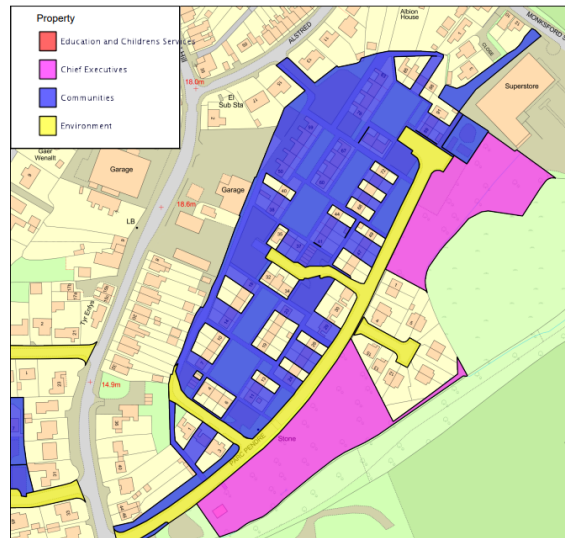
Figure 12 – Map of CCC land ownership at Clos Yr Helyg, Kidwelly.

7.5.2.2.1 Post the October 2021 flooding events, the Clos Yr Helyg watercourse has been added to the FDCP asset database. The land through which the watercourse flows is partially CCC land, as depicted in Figure 12.

7.5.2.2.2 This investigation has found no evidence of maintenance of this watercourse over the years. As such, its ability to receive and convey surface water has been compromised.

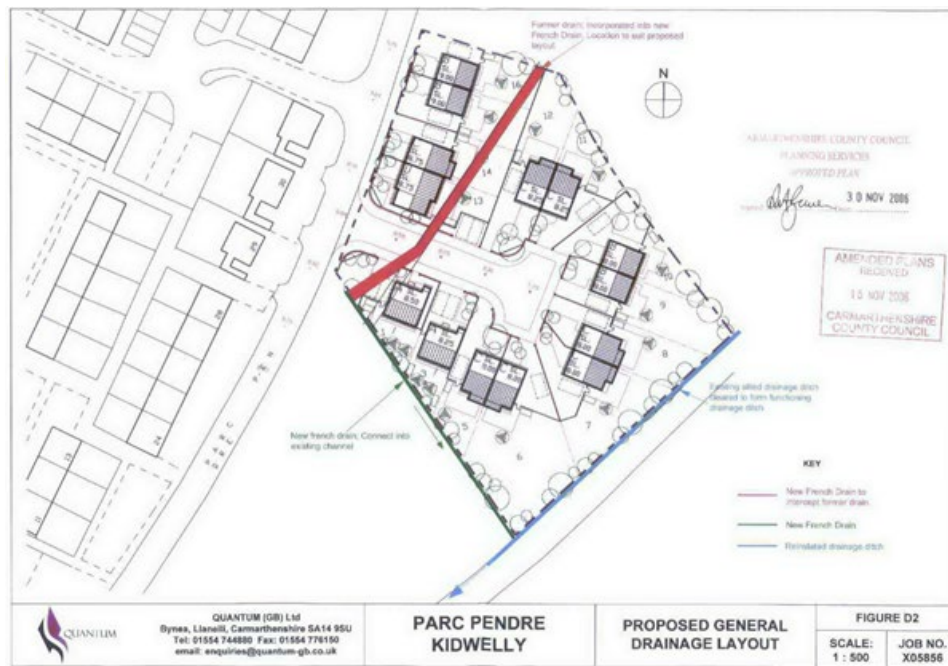
Figure 15 – Map of the approved surface water drainage design for Clos Yr Helyg (Quantum, 2006).

7.6.5 The approved surface water drainage design involved the remodelling of the former drain/watercourse into a new French drain running across the development and discharging into the reinstated drainage ditch running along the south-eastern boundary, as shown below in Figure 15.

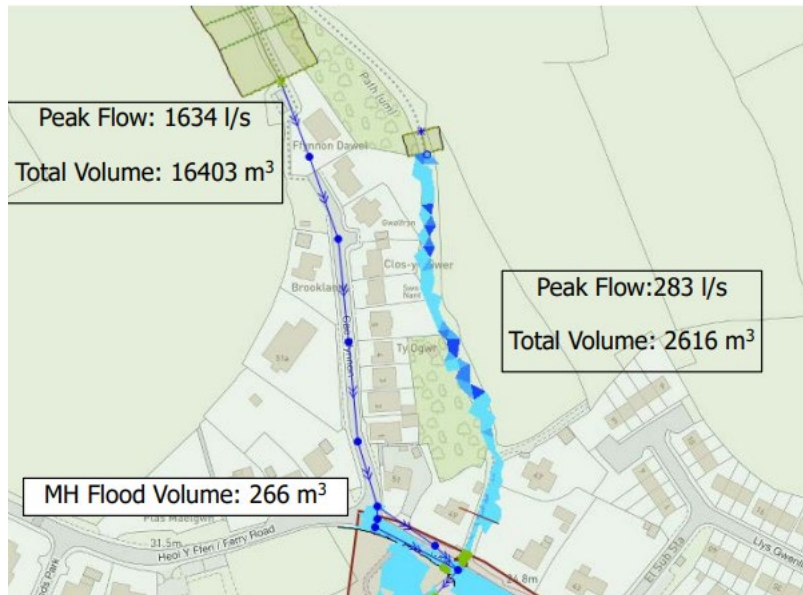
Figure 31 - Hydraulic modelling output of a 1 in 100-year (0.1% AEP) flood event - showing no surcharge at the Cae Ffynnon trash screen (Amey Consulting, March 2022).

10.6.2.1.3 An evaluation undertaken as a part of this investigation has concluded that this asset is fit for purpose, with the ability to manage flood flows up to the 1 in 100-year annual probability flood event (1% AEP). **Error! Reference source not found.** below depicts the flood modelling outputs and shows no predicted flooding during the modelling of this storm event.

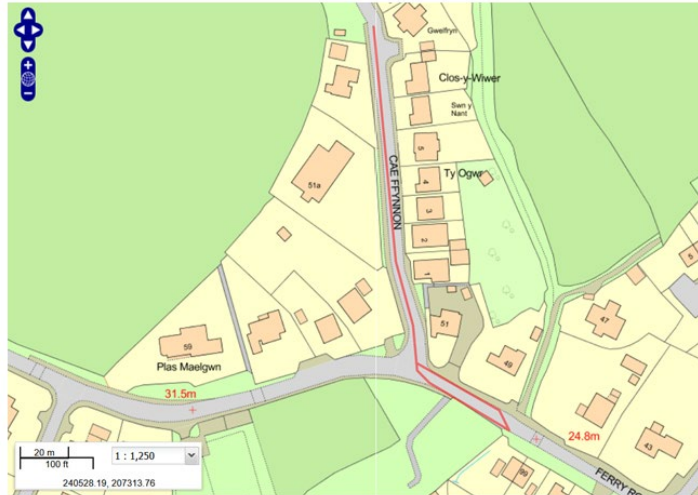
Figure 33 - CCC owned section of the Cae Ffynnon watercourse.

10.6.2.2.2 As such, approximately 145 metres of the culverted watercourse, beneath Cae Ffynnon, as denoted in Figure 33, is the responsibility of CCC as the Highways team.

10.6.2.2.3 This section of culvert is concrete and 750mm in diameter. It was last surveyed on the 24<sup>th</sup> September 2018. No issues or defects were noted.

10.6.2.2.4 At the bottom of Cae Ffynnon, the culverted watercourse bifurcates and there is a mixture of pipe sizes ranging from 450mm to 900mm. The 2018 culvert survey did highlight that a section of this culvert was damaged and that broken pieces of the culvert were trapped in the structure.

Improve communication and recording of defects between teams and divisions in CCC.
