16 Dafen Ward, Exchange Row Policy Unit

16.1 Area Description

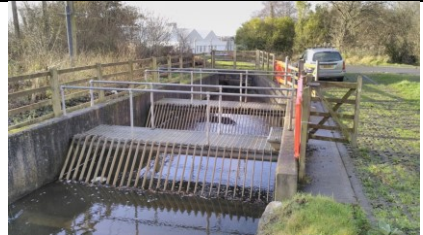
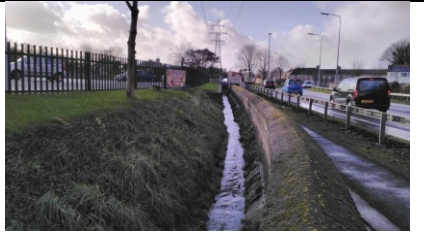
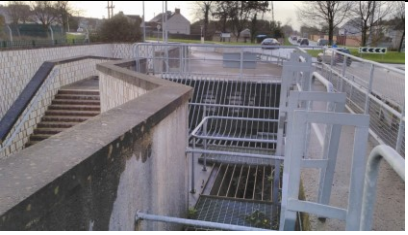
Dafen Trash Screen Upper (at entrance to former Avon Inflatables)	River wall alongside B4148	Dafen Roundabout Trash Screen

River Dafen Earth Bund	River Dafen Left Bank Kerb Wall	River Dafen Right Bank Kerb Wall
Exchange Row Culvert
